REPORT ON ARCHEOLOGICAL INVESTIGATIONS
CONDUCTED FOR THE INSTALLATION OF A DRAINAGE
SYSTEM AT FORT MOULTRIE NATIONAL MONUMENT

Southeast Archeological Center
National Park Service
Tallahassee, Florida

July 1993

Ken S. Wild

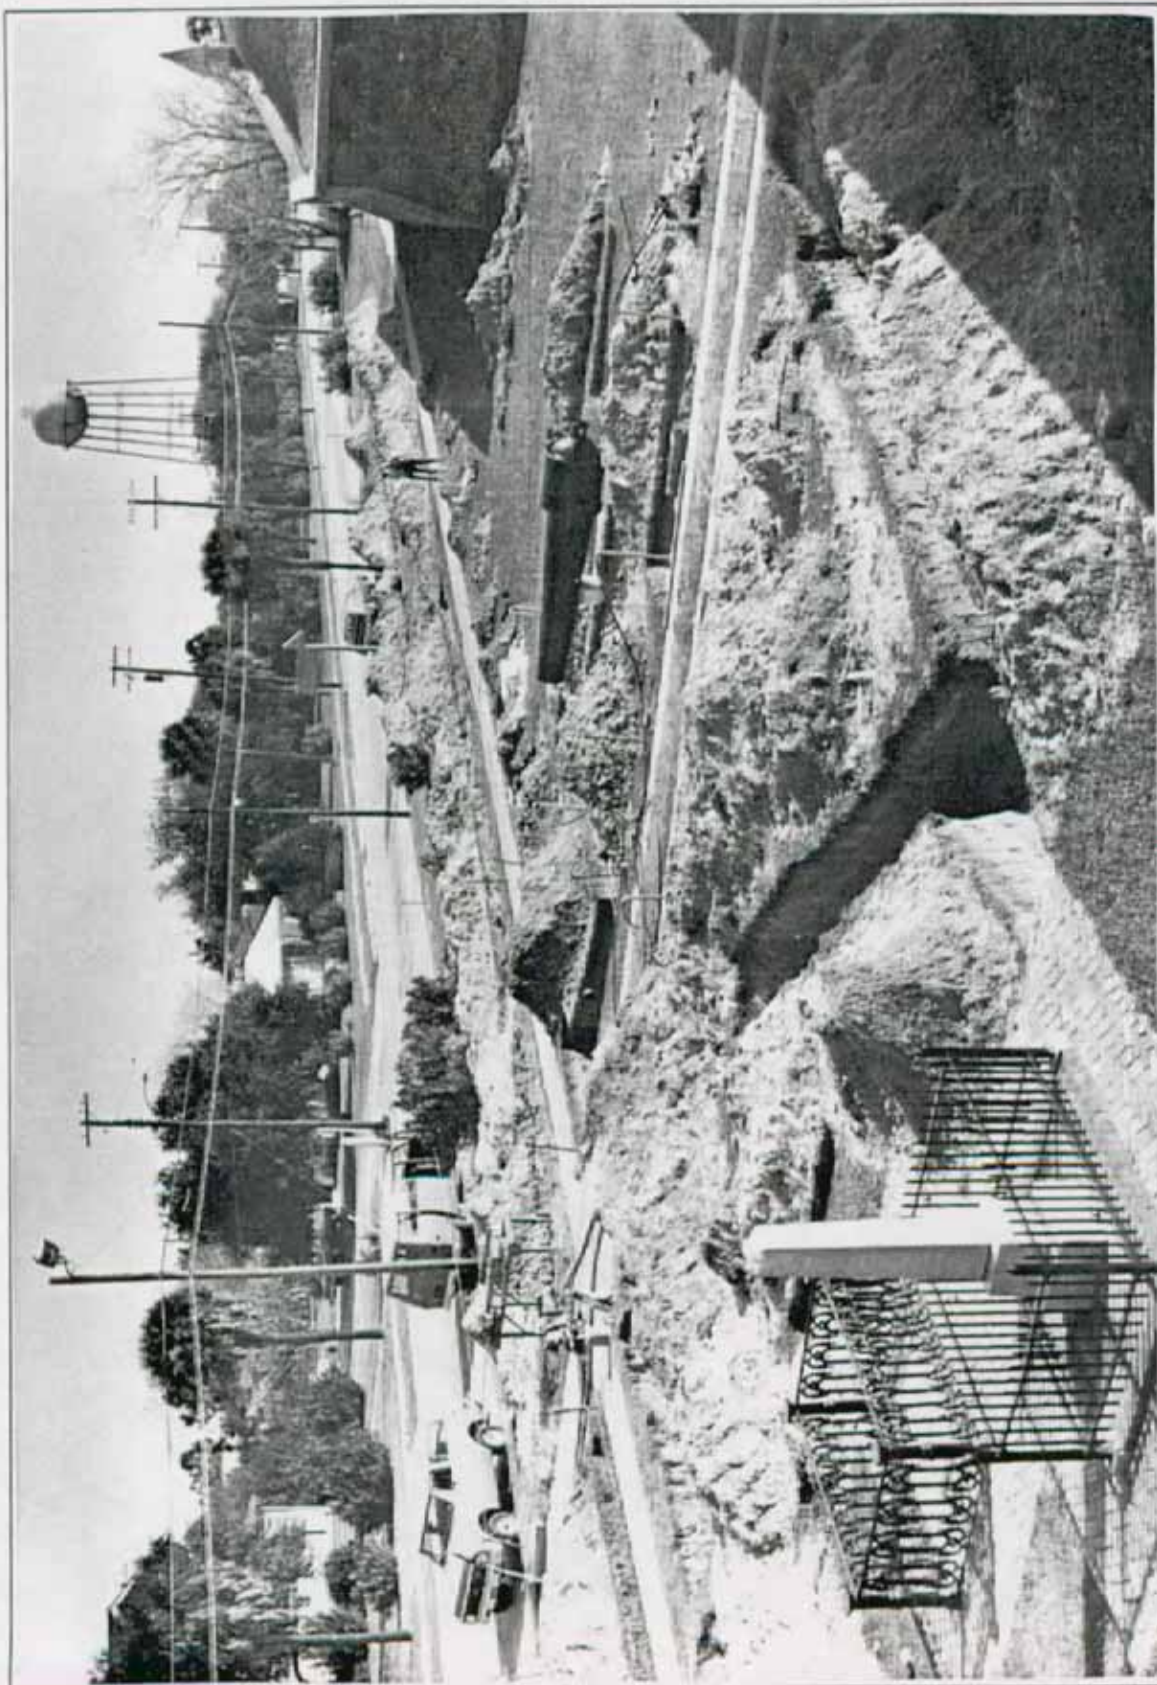
Figure 3. Photograph Taken in 1973 of Excavations Conducted by Stanley South (Source: South 1974).

trenches in the front yard (Figure 3). One of South's old trenches (#31) was located on the west side of the front lawn by excavating the fill and sod from a six inch wide slot trench. The pipe was routed west and laid in South's trench. Excavation in this disturbed area was conducted with a ditchwitch. At the end of Trench #31 another eight foot wide shallow trench was excavated, during this project, with the backhoe (Trench 3). In Trench 3 the pipe was directed around a large brick feature. At the corner of the northwest bastion an old pipe line was found. The route of this old pipe was excavated by hand to the original trench depth. The old pipe extended from the northwest corner south, approximately one third the length of the fort's west wall. Hand excavation of this ten inch wide 18 inch deep trench continued past the terminal point of the old pipe, along the fort wall to the west wall entrance walk and then west along this walk. This area was filled or previously disturbed to the depth excavated; no archeological features were encountered. At the western extension of the west entrance sidewalk, the drain pipe was routed south under the walk and towards the bay. Excavation from the walk to the bay was completed with a ditchwitch; the soils in this area are composed of recent fill. The probability of locating intact remains at the depth of excavation was slim, however, the trenching was monitored.

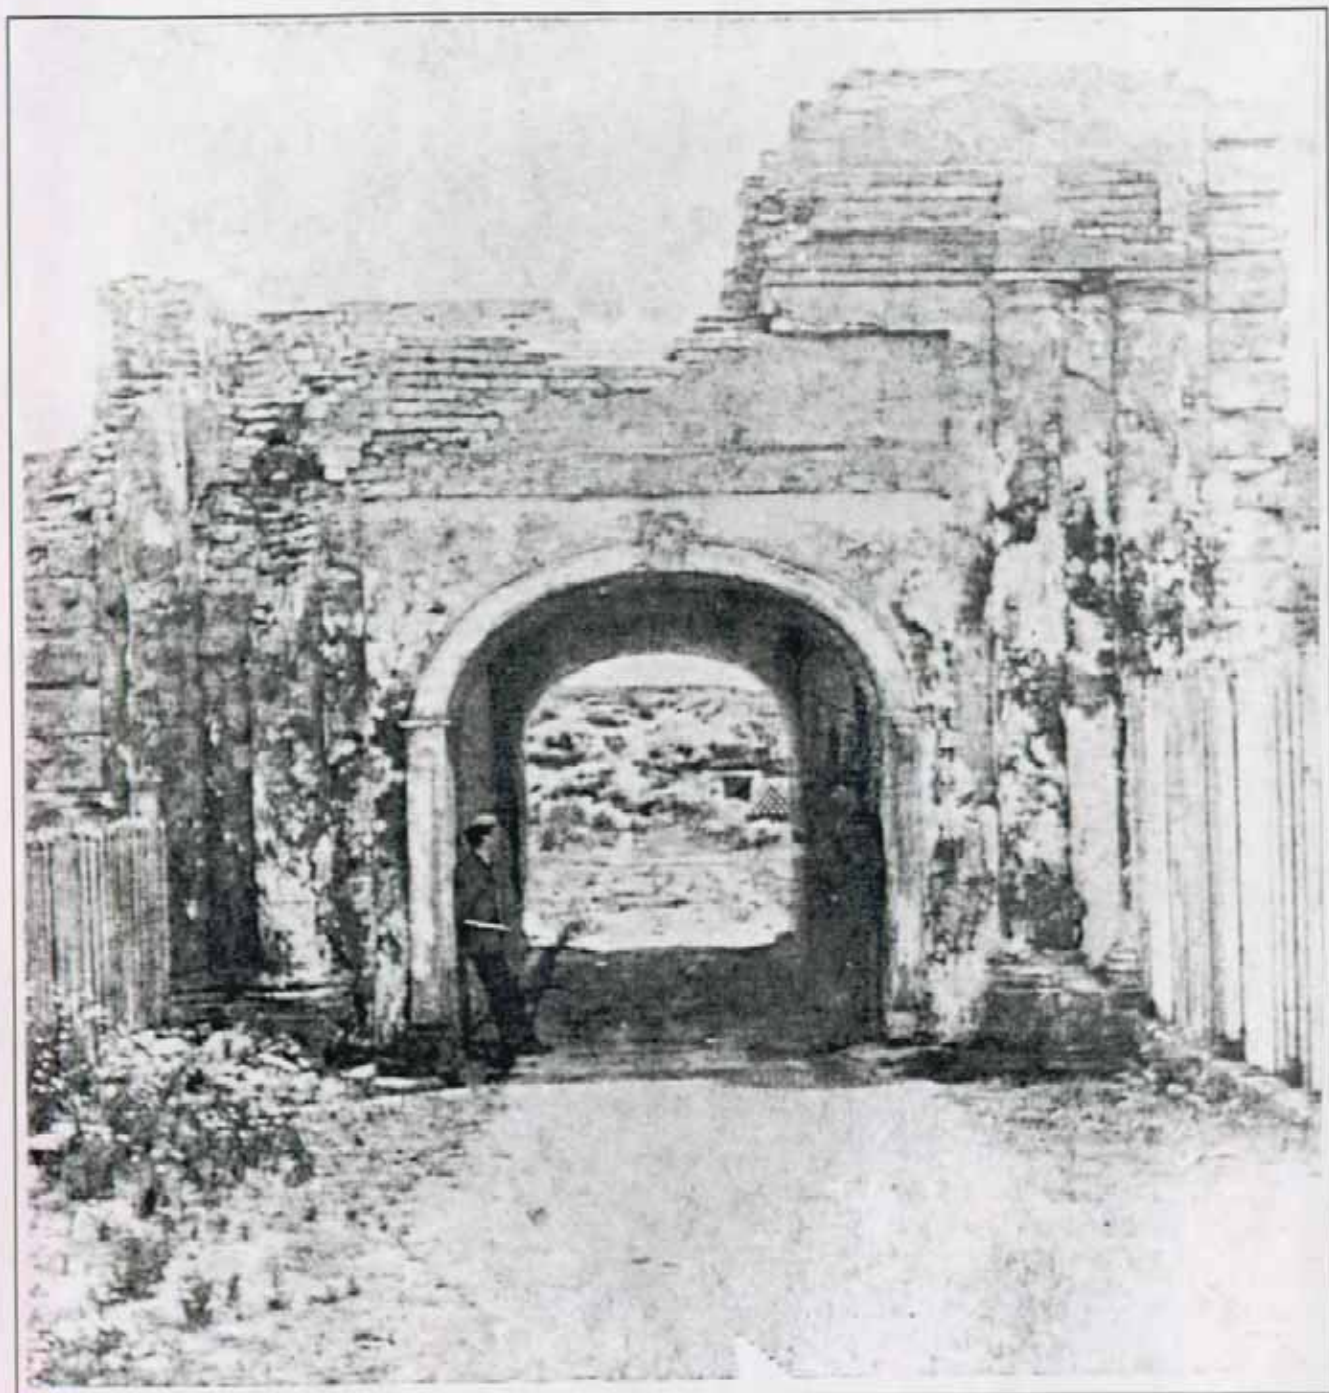
Figure 13. Photograph of Fort Moultrie Taken in 1870.

During the Civil War, occupation of the fort switched three times between the Federal and Confederate forces. Confederate forces evacuated Fort Moultrie III on the 17th of February 1865. Soon after Federal troops reoccupied the fort in 1865 a photographer documented the war's destruction. One photograph depicts structures butted against the fort's curtain wall on either side of the sally port, also, a structure along the flanking wall of the northwest bastion and what appear to be temporary buildings in the northwest half of the front yard. The buildings along the curtain wall are constructed of wood planking with windows and brick chimneys (Figure 12). The brick paved entrance walk is absent. However, the brick border along either side of the entrance walk is present. A photograph taken in 1870, of the sally port entrance, illustrates that the ca. 1865 structures were removed. A wooden fence rests on the brick entrance border where the structures stood (Figure 13).

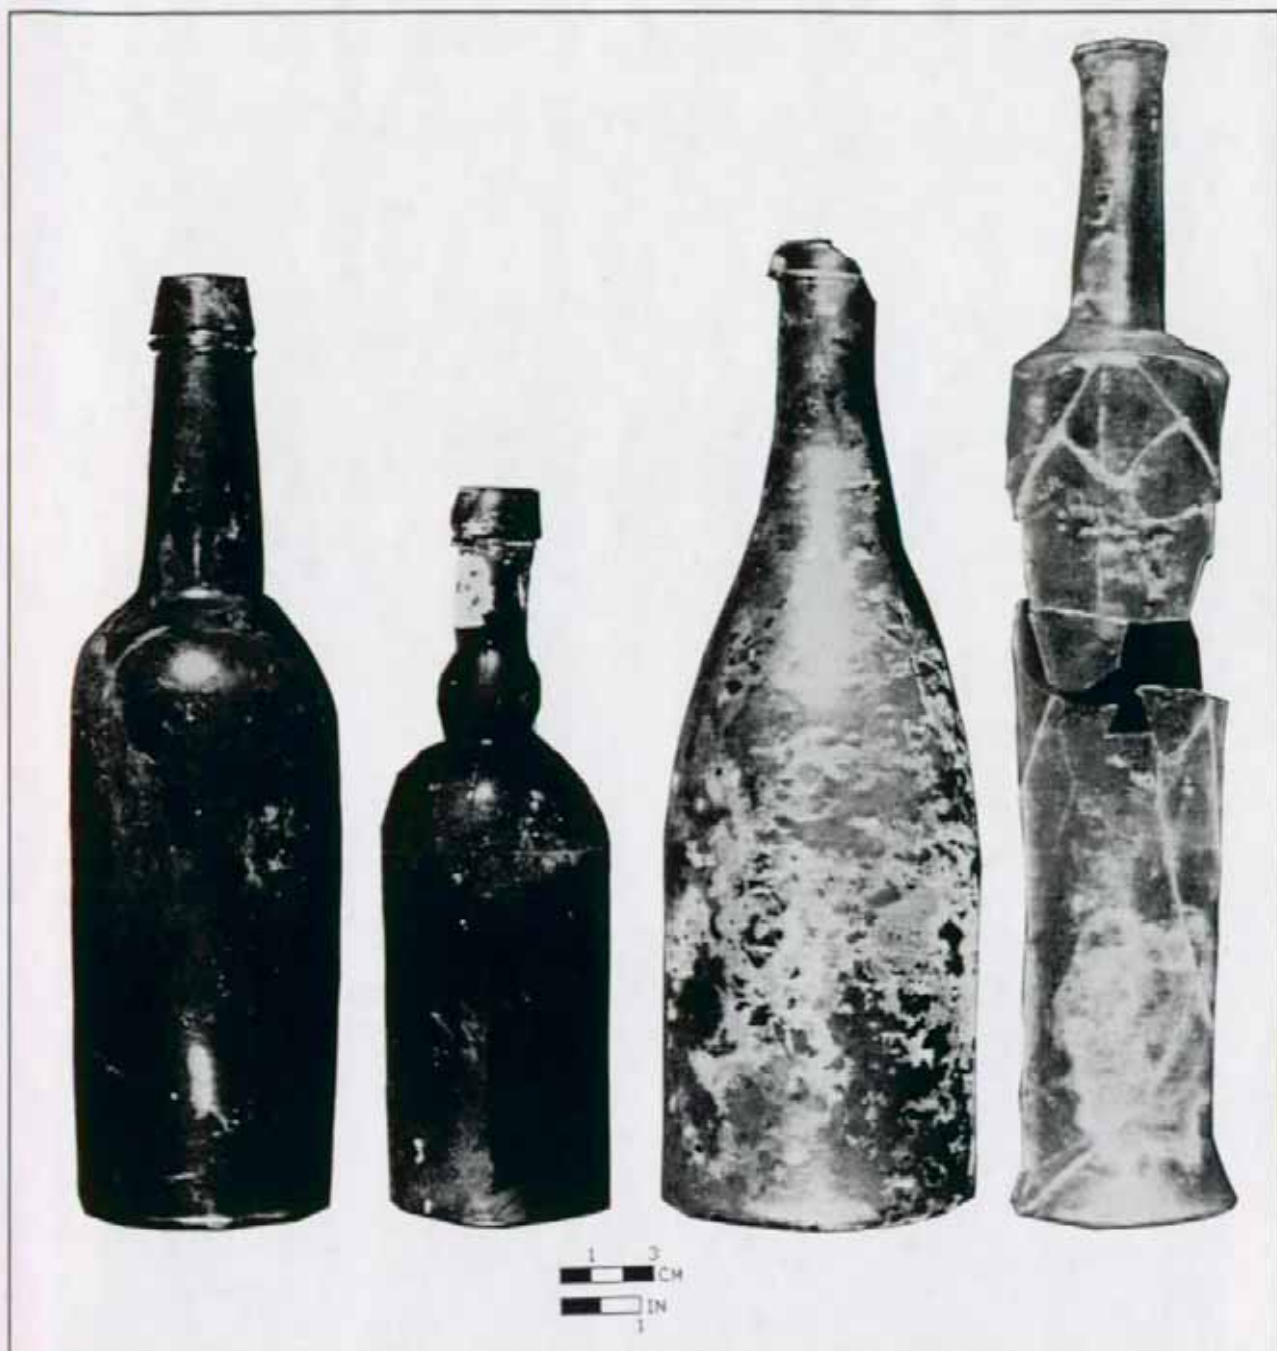
Figure 16. Ale (FOSU-7064), Bourbon (FOSU-7028), Champagne (FOSU-6919), and Tall Thin Glass Bottle (FOSU-7059) from Feature 17.

Artifact analysis confirmed a correlation between Feature 17 and the structure in the 1865 photograph. A considerable amount of window glass and nails were recovered, as would be expected from a wooden structure with windows. Of the 85 nails, the few that were identifiable are typical cut nails manufactured in the nineteenth century. A variety of brass spikes, nails, and tacks were collected. A hat pin initially suggested Feature 17 is associated with Federal occupation of the fort (Howell 1975). The pin was used to fold the Union Hardee Hat. The bottles confirmed Union occupation, as several of those collected were manufactured in northern states. Twenty-six bottles were removed from the surface of the feature. Many more whole and fragmented bottles are embedded; these were left *in situ*. Eleven whole dark green beer or ale bottles were collected, three of which are embossed B 14 on the base and eight with B 204 (Figure 16). The B was a trade mark for the Baltimore Glass Works which was in business from the 1790s to 1890 (Van Resselaeer 1969). Two of the five bourbon bottles are complete; one was manufactured in Philadelphia by the Dyottville Glass Works (Figure 16). A complete Champagne bottle (Figure 16), a ceramic ale bottle, and an unusually thin but tall clear glass bottle (Figure 16) were also recovered.

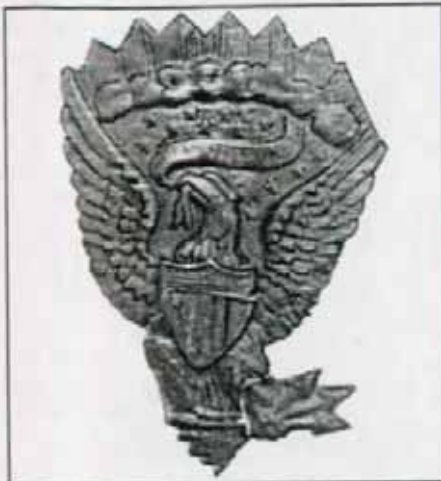
Figure 17. Hardee Hat Pin (FOSU-7028) from Feature 17. Actual Size.

Period include: the Hardee Hat pin (Figure 17), a friction primer of the type that fits an 1853 Einfield, in use throughout the Civil War, a minnie ball, a light blue glass fragment from a four ounce cologne bottle identified by the embossed lion and dated to between 1830-1860s (McKearin and Wilson 1978), and nineteenth century ceramic fragments of whiteware yellowware (Moore 1985). Two complete pipe bowls and a number of pipe stems were collected. The vertical angle of the bowls, the decoration, and the absence of a heel suggest they date to the mid nineteenth century (Walker 1977). A small vial from the feature may have contained opium (Talley Kirkland Jr., personal communications 1991); it is identical to those used in medical kits of the Civil War (Dammann 1983), (Figure 18).

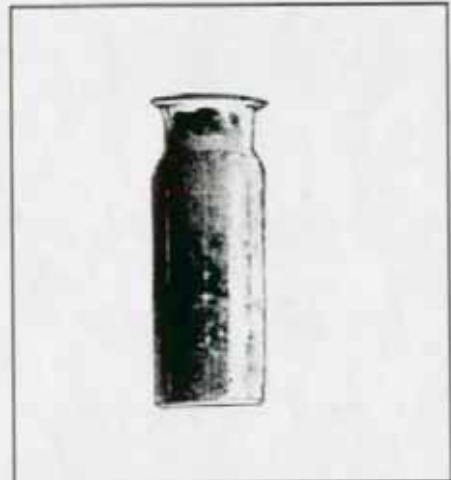
Figure 18. Possible Opium Vial (FOSU-7048) from Feature 17. Actual Size.

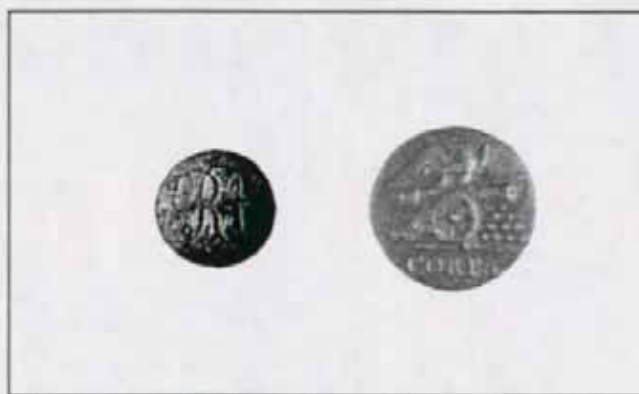
Figure 21. Button from the 1st Regiment of the Artillerists (FOSU-6997) and Artillery Corps Button (FOSU-7142). Actual Size.
